STUDIES OF THE FATIGUE BEHAVIOR OF BUTT-WELDED JOINTS IN HY-80 AND HY-100 STEELS

By
W. H. MUNSE
W. H. BRUCKNER
A. J. HARTMANN
J. B. RADZIMINSKI
R. W. HINTON
and
J. L. MOONEY

THE CIVIL ENGINEERING DEPARTMENT
UNIVERSITY OF ILLINOIS
in cooperation with

NOVEMBER, 1964

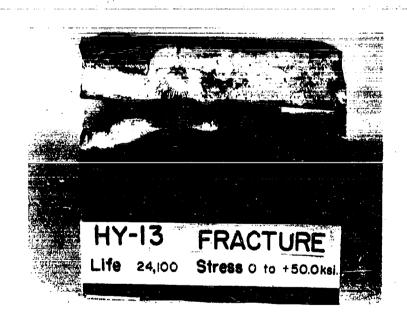
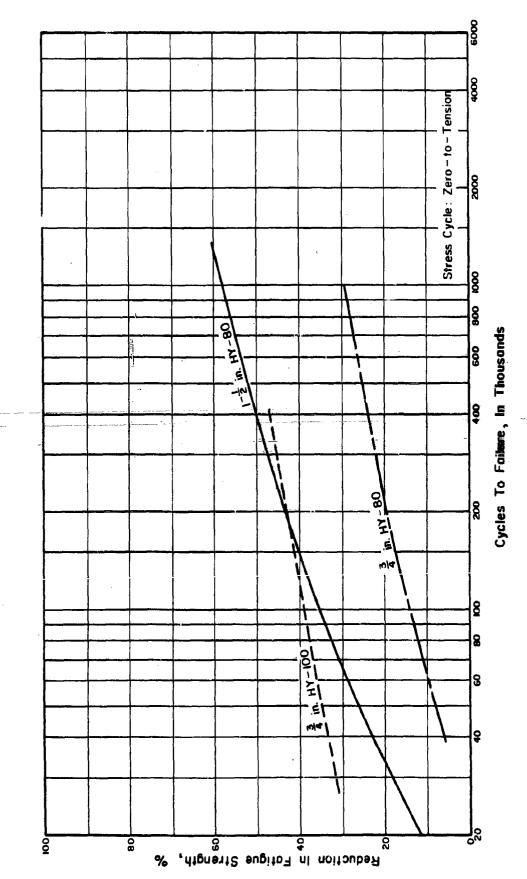
it can be seen on Fig. 3.5 that there was a large amount of scatter in the test results when failure occurred in the weld. In addition the failures propagated rapidly when they originated in the weld. When failure occurred in

d) FAILURE INITIATED AT EDGE OF WELD REINFORGEMENT.

b) FAILURE INITIATED IN WELD.

FIG.3.6 TYPICAL FRACTURES OF TRANSVERSE BUTT WELDS IN 3/4 IN HY-100 MATERIAL.

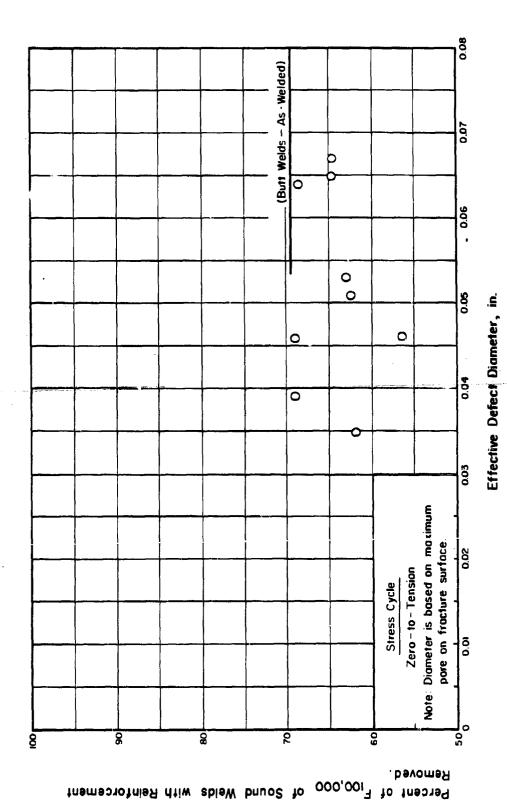
The geometry of the porosity in the 1-1/2 in thick material was similar to that of the 3/4 in thick material which was discussed extensively in a previous report (4). The majority of natural defects were roughly spherical or ellipsoidal, Fig. 4.2a. The minimum distance from the surface of the weld to the porosity ranged from 7/16 in to 9/16 in for the 1-1/2 in thick material and 7/32 in to 5/16 in for the 3/4 in thick plate. All specimens in the present test series with natural porosity were fabricated to produce a single cluster of porosity. Specimens G-81 and G-88 each had fatigue cracks that grew from the main cluster of porosity as well as from other small defects located some distance from the cluster. Specimen G-81 had the lowest life and specimen G-88 had the longest life of the specimens tested at 0 to +50.0 ksi.

a) POROSITY IN WELD.

b) SLAG IN WELD.

FIG. 4.2 TYPICAL FRACTURES FOR I-1/2 IN.
